**Flood Control Project Maintenance
Levee Inspections**

Fall 2011 Levee Maintenance Deficiency Summary Report

Reclamation District No. 0544 Upper Roberts Island

Levee Inspection Report By Mile - Fall 2011

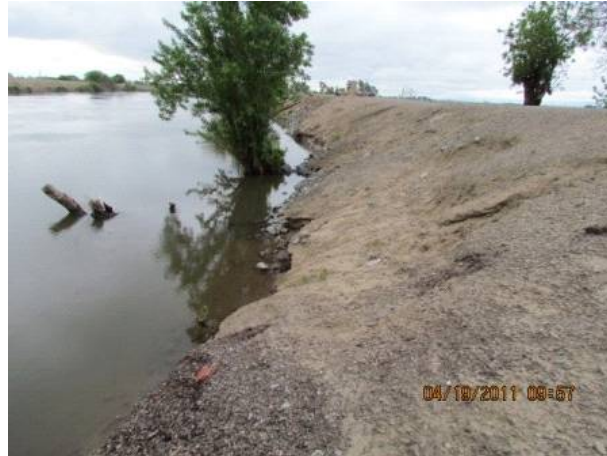
richard_f_20111014_680.jpg

Levee Mile Report Line	1
Start Levee Mile	0.00
End Levee Mile	0.02
Location	Water Side
Category	Earthen Levee
Item	Erosion / Bank Caving

Looking south at erosion and slope stability issue.

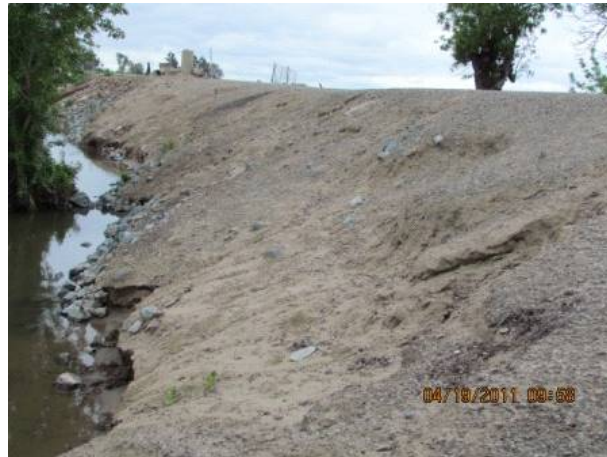
richard_f_20111014_681.jpg

Levee Mile Report Line	1
Start Levee Mile	0.00
End Levee Mile	0.02
Location	Water Side
Category	Earthen Levee
Item	Erosion / Bank Caving

Looking south at waterside erosion and slope stability.

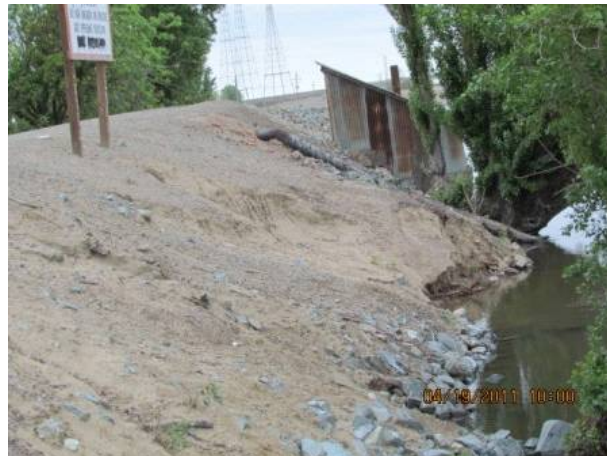
richard_f_20111014_682.jpg

Levee Mile Report Line	1
Start Levee Mile	0.00
End Levee Mile	0.02
Location	Water Side
Category	Earthen Levee
Item	Erosion / Bank Caving

Looking north at waterside erosion and slope stability.

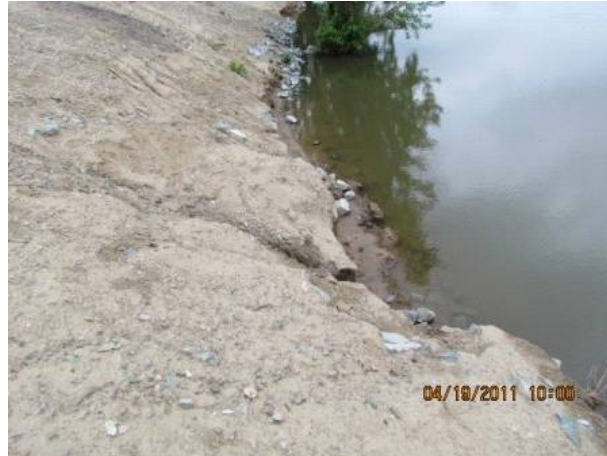
richard_f_20111014_683.jpg

Levee Mile Report Line	1
Start Levee Mile	0.00
End Levee Mile	0.02
Location	Water Side
Category	Earthen Levee
Item	Erosion / Bank Caving

Looking north at erosion along waterside slope and toe.

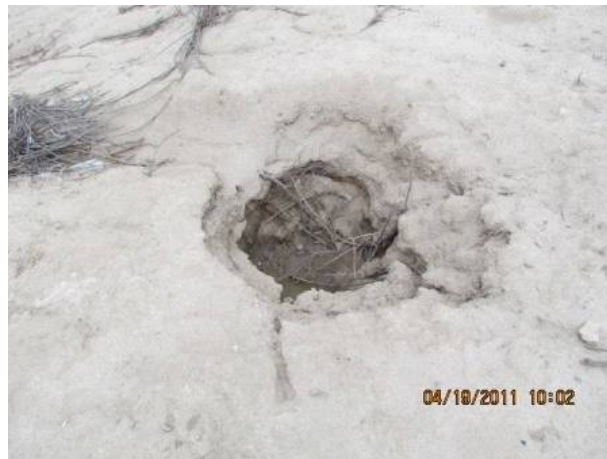
richard_f_20111014_684.jpg

Levee Mile Report Line	2
Start Levee Mile	0.04
End Levee Mile	0.04
Location	Land Side
Category	Earthen Levee
Item	Slope Stability

Looking at sink hole (approx. 36" deep and 72" in diameter) on landside shoulder and slope.

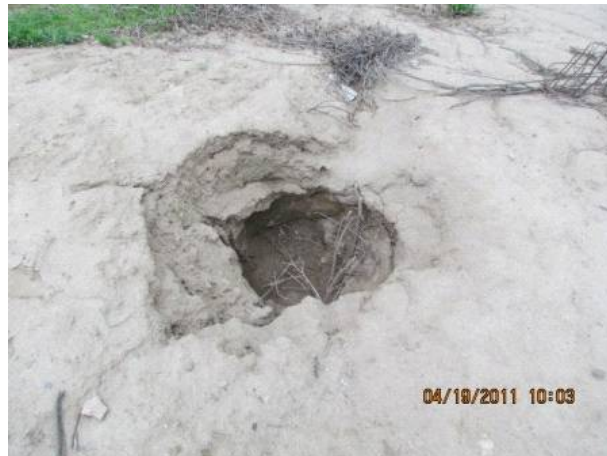
richard_f_20111014_685.jpg

Levee Mile Report Line	2
Start Levee Mile	0.04
End Levee Mile	0.04
Location	Land Side
Category	Earthen Levee
Item	Slope Stability

Looking east at sink hole on landside shoulder.

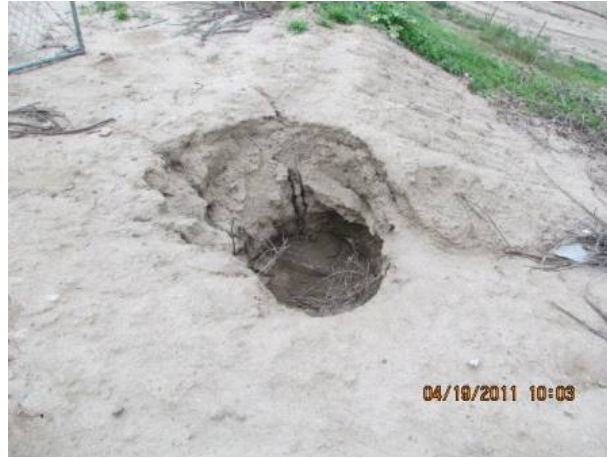
richard_f_20111014_686.jpg

Looking south at sink hole on landside shoulder.

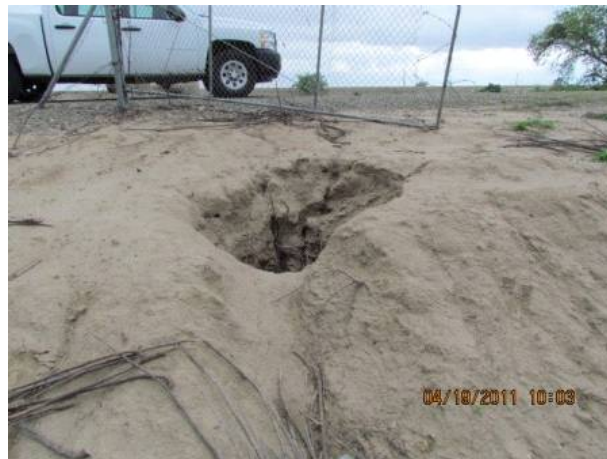
richard_f_20111014_687.jpg

Levee Mile Report Line	2
Start Levee Mile	0.04
End Levee Mile	0.04
Location	Land Side
Category	Earthen Levee
Item	Slope Stability

Looking east at sink hole on landside shoulder.

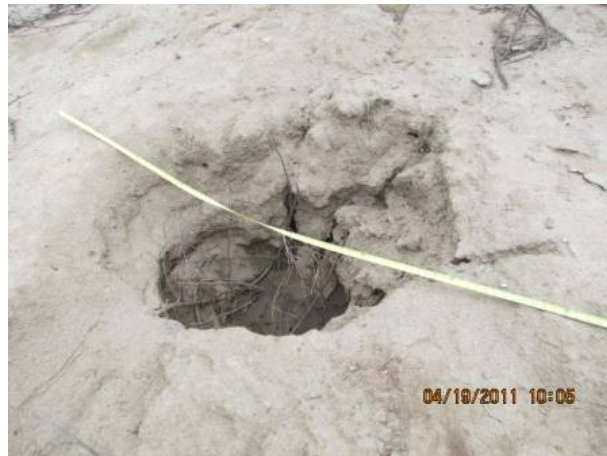
richard_f_20111014_688.jpg

Levee Mile Report Line	2
Start Levee Mile	0.04
End Levee Mile	0.04
Location	Land Side
Category	Earthen Levee
Item	Slope Stability

Sink hole on measuring 36" deep by 72" in diameter.

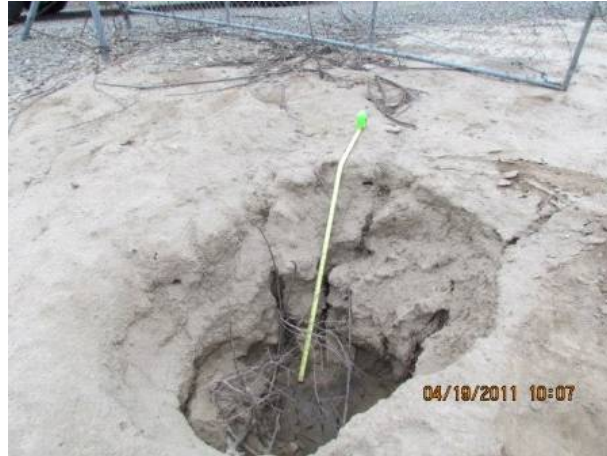
richard_f_20111014_689.jpg

Sink hole on landside shoulder approx. 36" deep.

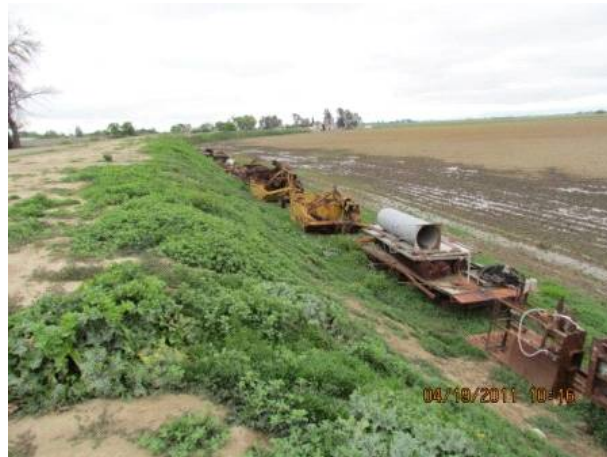
richard_f_20111014_671.jpg

Levee Mile Report Line	3
Start Levee Mile	0.05
End Levee Mile	0.18
Location	Land Side
Category	Earthen Levee
Item	Encroachments

Looking south at equipment along landside toe.

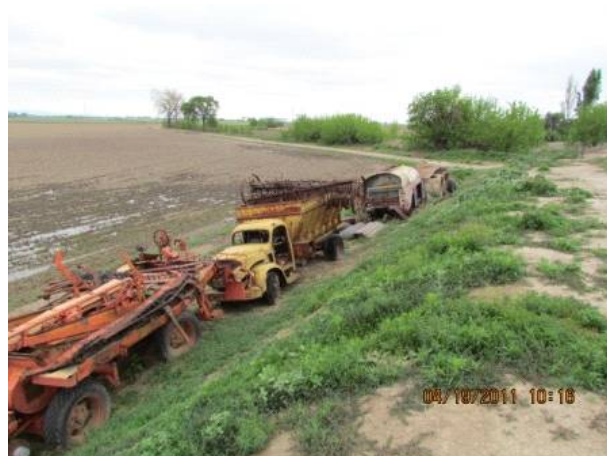
richard_f_20111014_672.jpg

Levee Mile Report Line	3
Start Levee Mile	0.05
End Levee Mile	0.18
Location	Land Side
Category	Earthen Levee
Item	Encroachments

Looking north at equipment along landside toe.

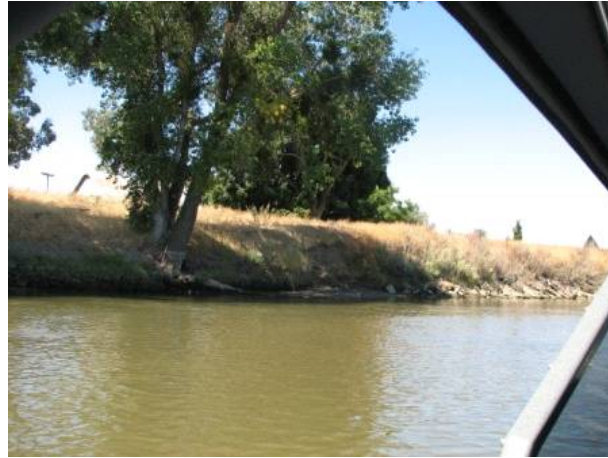
SJR2011_RD0544U01RM47.12_1.jpg

Downstream view of the site where a 4-foot vertical scarp has occurred.

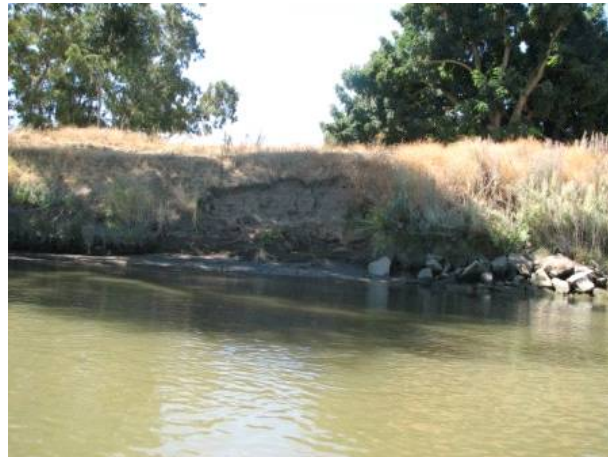
SJR2011_RD0544U01RM47.12_2.jpg

Levee Mile Report Line	4
Start Levee Mile	0.41
End Levee Mile	0.45
Location	Water Side
Category	Supplemental
Item	DWR Erosion Survey

Upstream view of the site where undermining of the slope has occurred.

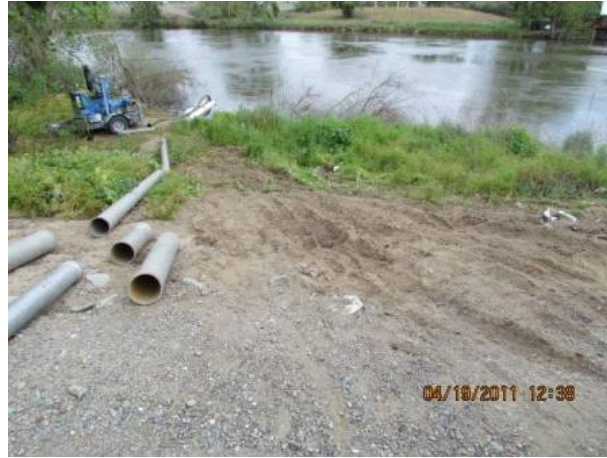
richard_f_20111014_673.jpg

Looking east at landowner installing temporary pump system without permit and damage to waterside slope.

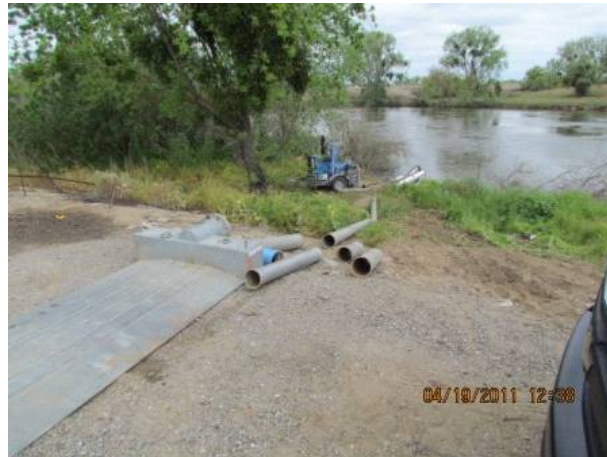
richard_f_20111014_674.jpg

Levee Mile Report Line	27
Start Levee Mile	2.98
End Levee Mile	2.98
Location	Land Side
Category	Earthen Levee
Item	Encroachments

Looking east at pump and irrigation ramp on levee waterside and crown.

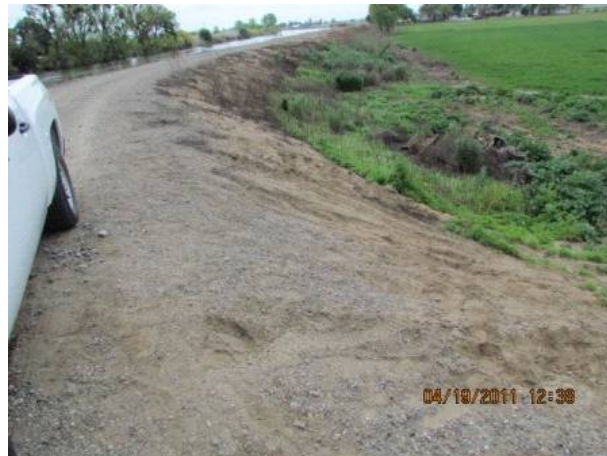
richard_f_20111014_675.jpg

Levee Mile Report Line	27
Start Levee Mile	2.98
End Levee Mile	2.98
Location	Land Side
Category	Earthen Levee
Item	Encroachments

Looking south at damage landside slope caused by vehicle traffic.

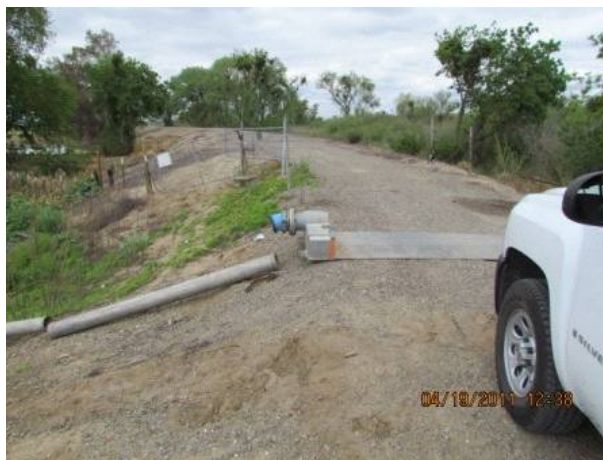
richard_f_20111014_676.jpg

Looking north at pipe and pipe ramp on landside and crown of levee.

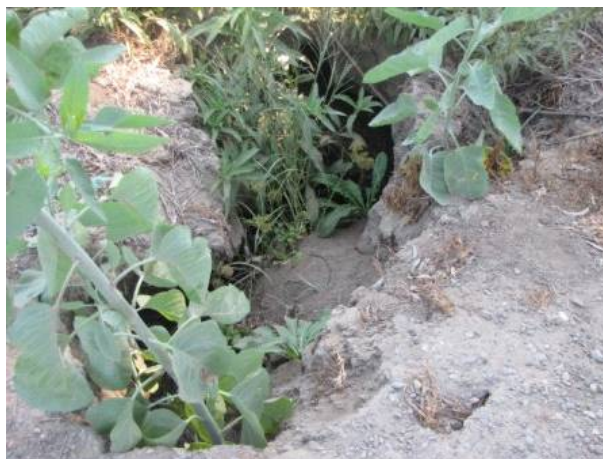
richard_f_20111014_691.jpg

Levee Mile Report Line	38
Start Levee Mile	4.32
End Levee Mile	4.32
Location	Water Side
Category	Earthen Levee
Item	Slope Stability

Looking east at erosion on waterside slope and berm cause by leaking 10" pipe.

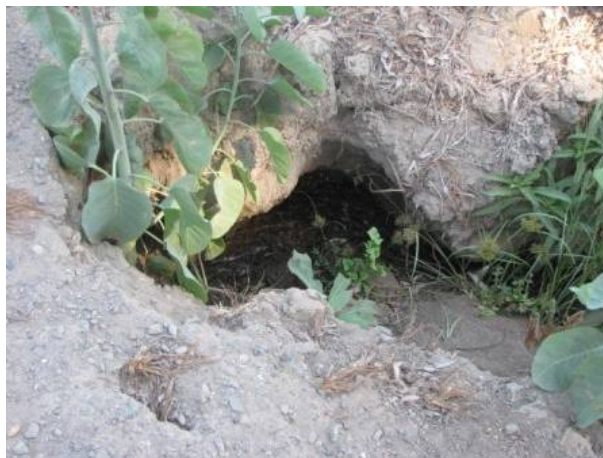
richard_f_20111014_692.jpg

Levee Mile Report Line	38
Start Levee Mile	4.32
End Levee Mile	4.32
Location	Water Side
Category	Earthen Levee
Item	Slope Stability

Looking west at hole on waterside shoulder and slope cause by possible broken pipe.

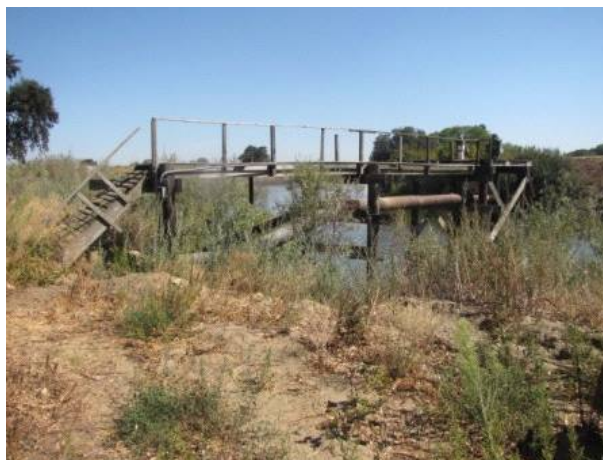
richard_f_20111014_693.jpg

Looking northwest at pump and platform for 10" possible leaking pipe.

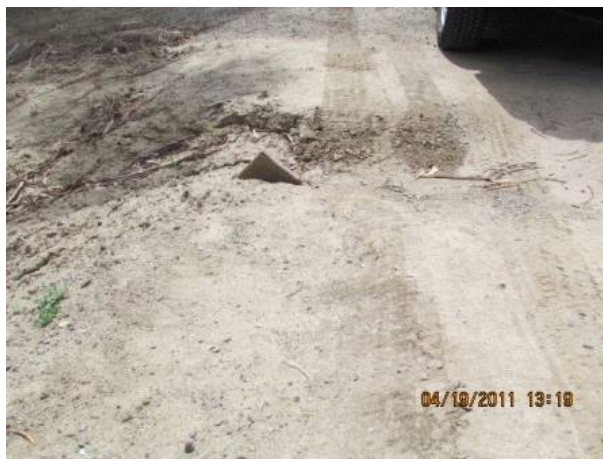
richard_f_20111014_694.jpg

Levee Mile Report Line	40
Start Levee Mile	4.33
End Levee Mile	4.33
Location	Crown
Category	Earthen Levee
Item	Crown Surface / Depressions / Rutting

Looking south at depression greater than 6" on waterside shoulder.

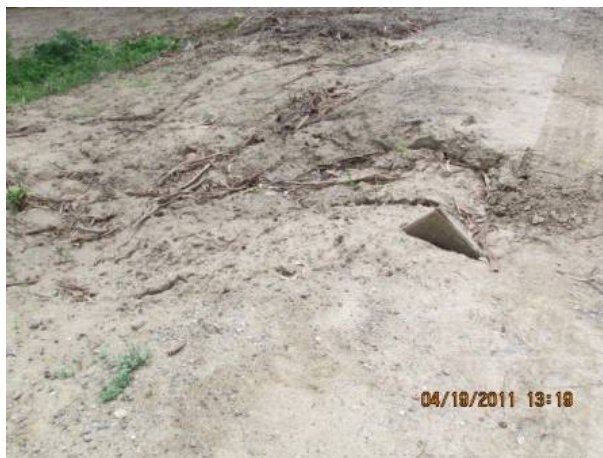
richard_f_20111014_695.jpg

Levee Mile Report Line	40
Start Levee Mile	4.33
End Levee Mile	4.33
Location	Crown
Category	Earthen Levee
Item	Crown Surface / Depressions / Rutting

Looking southeast at depression on waterside shoulder.

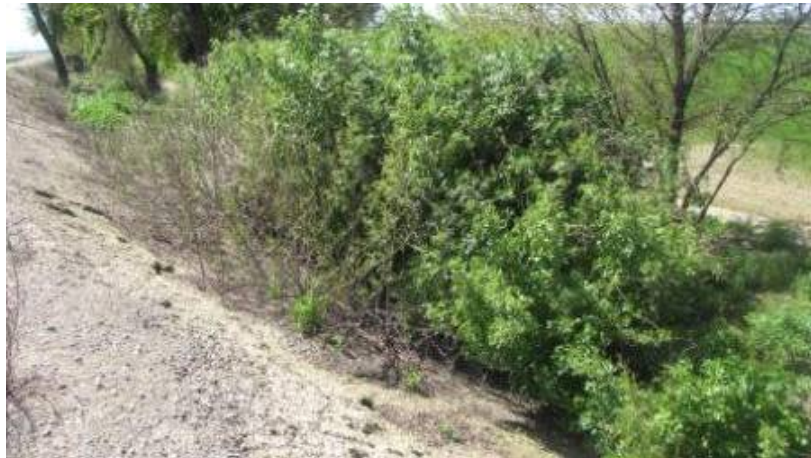
richard_f_20111014_690.jpg

Looking south at elderberries on landside slope and toe.

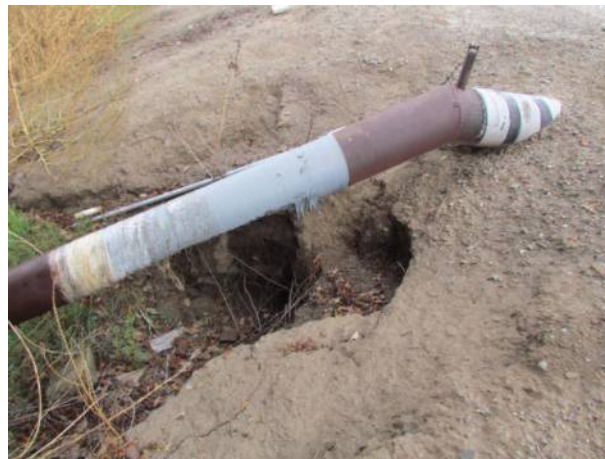
richard_f_20111130_463.jpg

Levee Mile Report Line	45
Start Levee Mile	4.75
End Levee Mile	4.75
Location	Land Side
Category	Earthen Levee
Item	Slope Stability

Looking north at erosion around irrigation pipe on landside

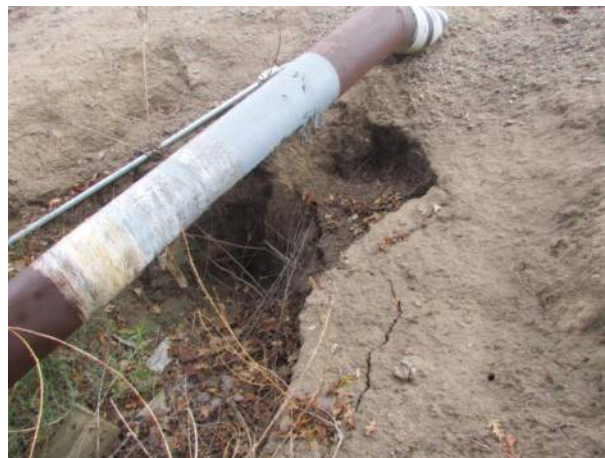
richard_f_20111130_464.jpg

Levee Mile Report Line	45
Start Levee Mile	4.75
End Levee Mile	4.75
Location	Land Side
Category	Earthen Levee
Item	Slope Stability

Looking northeast at erosion around irrigation pipe on landside slope.

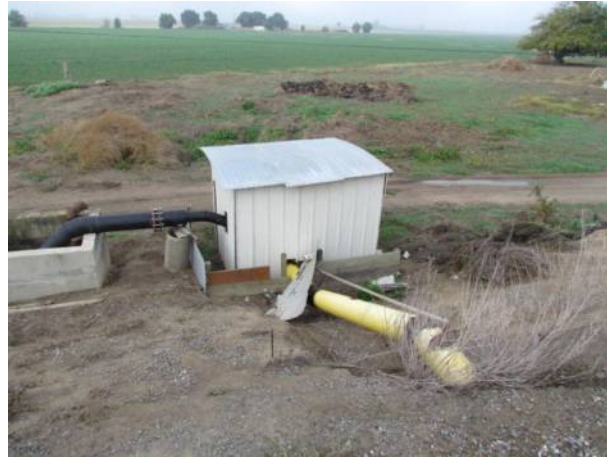
richard_f_20111130_465.jpg

Looking west on authorized pump house on landside toe.

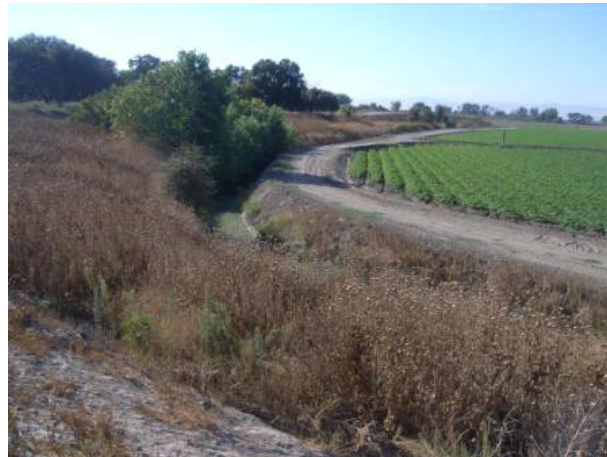
richard_f_20111130_466.jpg

Levee Mile Report Line	52
Start Levee Mile	4.96
End Levee Mile	4.96
Location	Land Side
Category	Earthen Levee
Item	Encroachments

Looking southwest at ditch on landside slope and toe.

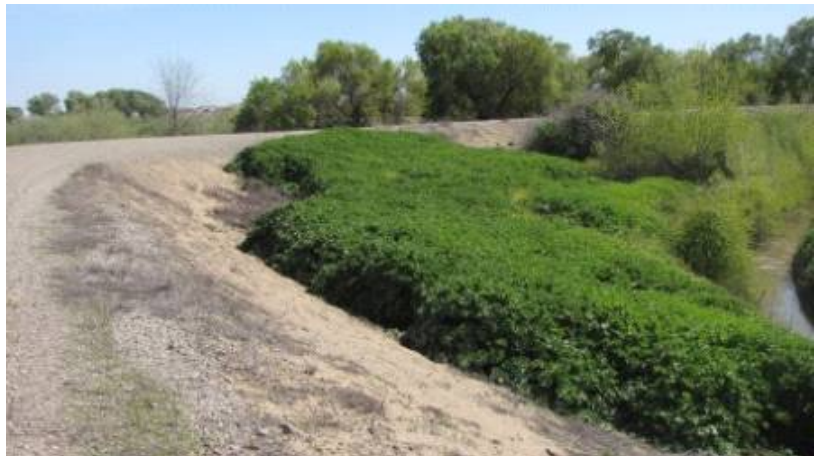
richard_f_20111014_679.jpg

Levee Mile Report Line	53
Start Levee Mile	5.00
End Levee Mile	5.30
Location	Land Side
Category	Earthen Levee
Item	Vegetation

Looking southeast at dense veg. on landside slope and toe.

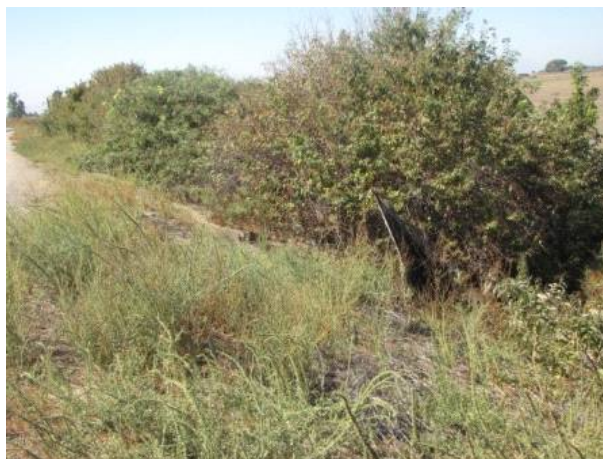
richard_f_20111014_678.jpg

Levee Mile Report Line	56
Start Levee Mile	5.54
End Levee Mile	5.60
Location	Land Side
Category	Earthen Levee
Item	Vegetation

Looking south at elderberries on landside slope and toe.

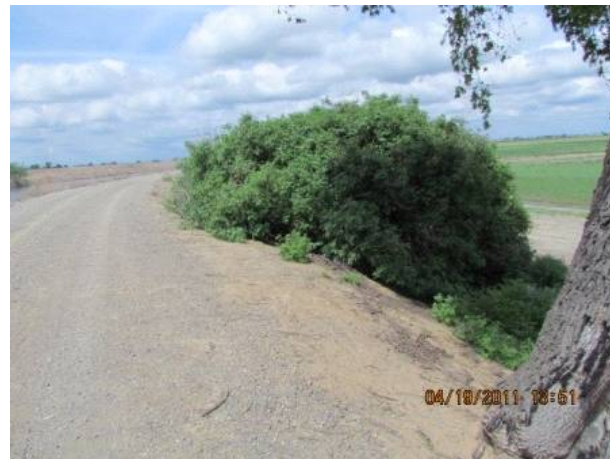
richard_f_20111014_817.jpg

Levee Mile Report Line	2
Start Levee Mile	0.41
End Levee Mile	0.41
Location	Land Side
Category	Earthen Levee
Item	Vegetation

Looking south at elderberries on landside slope.

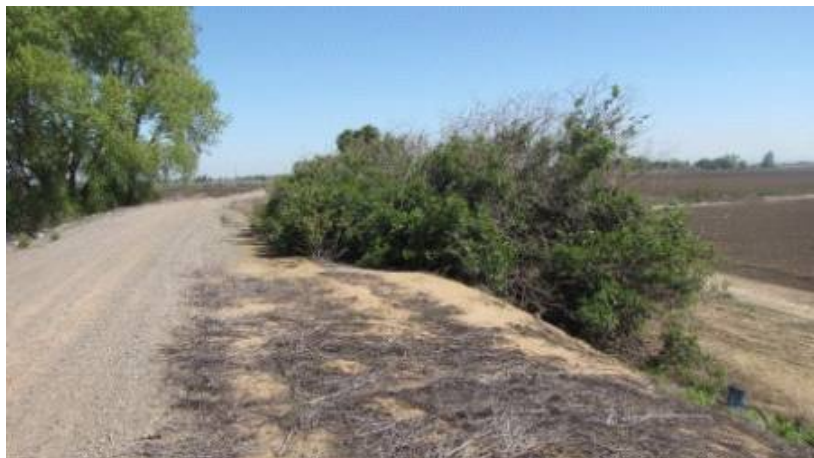
richard_f_20111014_818.jpg

Levee Mile Report Line	6
Start Levee Mile	0.74
End Levee Mile	0.74
Location	Land Side
Category	Earthen Levee
Item	Vegetation

Looking south at elderberries on landside slope and toe.

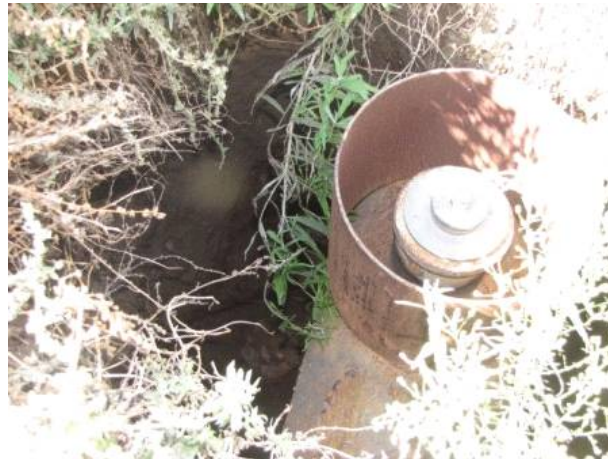
richard_f_20111014_820.jpg

Levee Mile Report Line	7
Start Levee Mile	0.79
End Levee Mile	0.79
Location	Water Side
Category	Interior Drainage & Piping Systems
Item	Erosion Areas

Looking at caving around 10" siphon pipe on waterside shoulder.

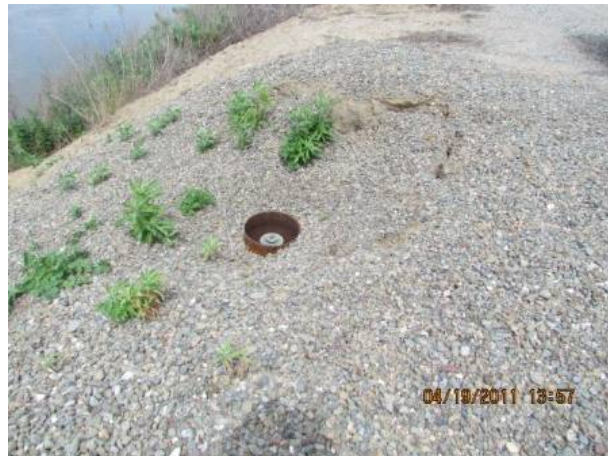
richard_f_20111014_821.jpg

Levee Mile Report Line	7
Start Levee Mile	0.79
End Levee Mile	0.79
Location	Water Side
Category	Interior Drainage & Piping Systems
Item	Erosion Areas

Looking south at depression greater than 6" on waterside shoulder.

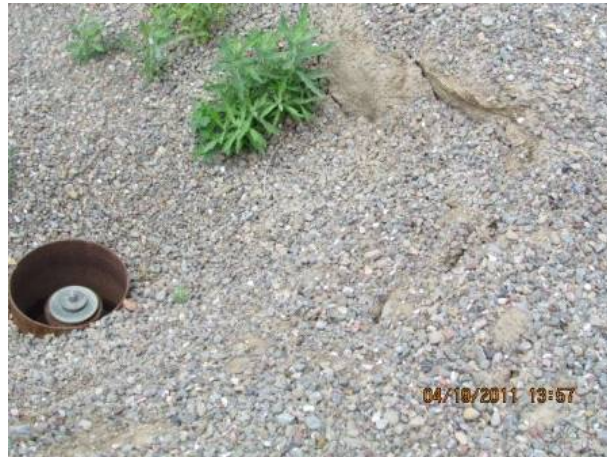
richard_f_20111014_823.jpg

Levee Mile Report Line	7
Start Levee Mile	0.79
End Levee Mile	0.79
Location	Water Side
Category	Interior Drainage & Piping Systems
Item	Erosion Areas

Looking at top of siphon with a depression greater than 6" on waterside shoulder.

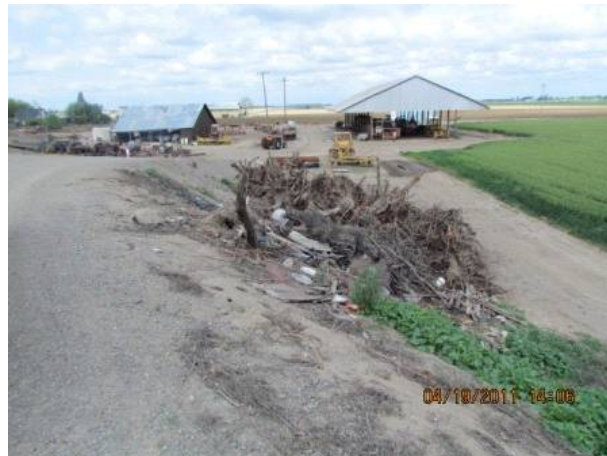
richard_f_20111014_830.jpg

Levee Mile Report Line	9
Start Levee Mile	1.14
End Levee Mile	1.14
Location	Land Side
Category	Earthen Levee
Item	Encroachments

Looking southwest at pruning pile on landside slope.

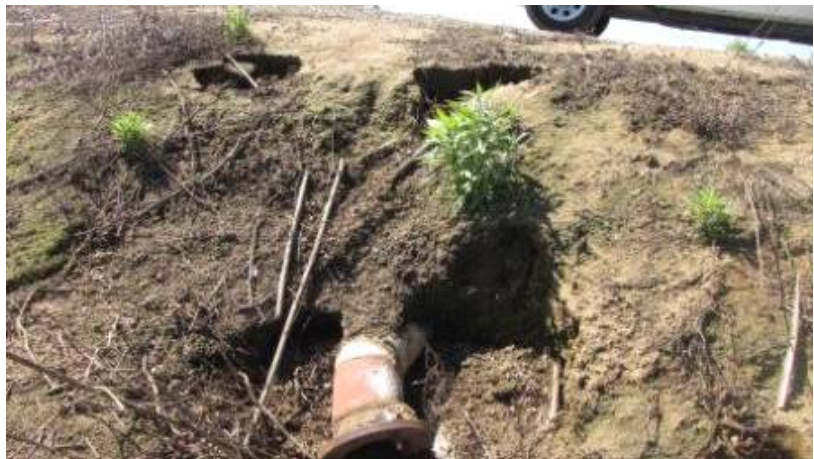
richard_f_20111014_832.jpg

Levee Mile Report Line	14
Start Levee Mile	1.40
End Levee Mile	1.40
Location	Land Side
Category	Earthen Levee
Item	Encroachments

Looking east at pipe and erosion just above pipe on landside slope and shoulder.

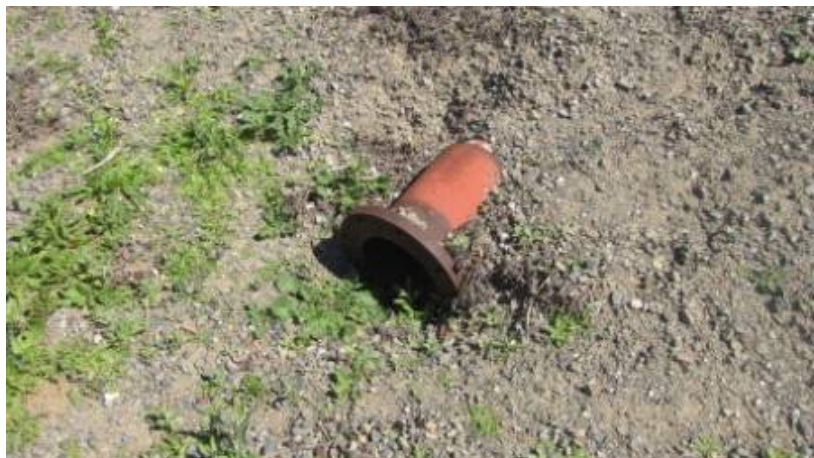
richard_f_20111014_833.jpg

Levee Mile Report Line	14
Start Levee Mile	1.40
End Levee Mile	1.40
Location	Land Side
Category	Earthen Levee
Item	Encroachments

Looking west at east end of pipe on waterside slope.

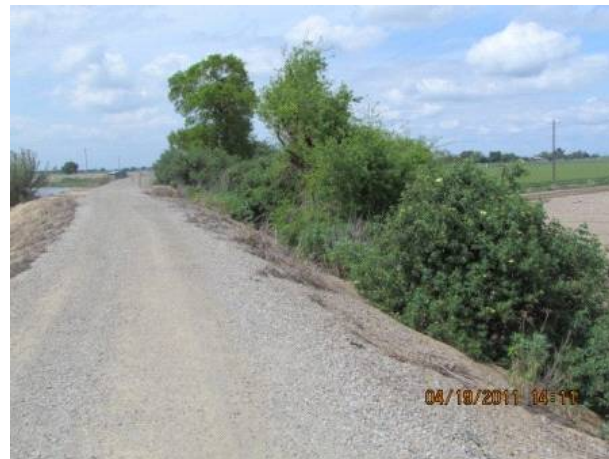
richard_f_20111014_825.jpg

Levee Mile Report Line	15
Start Levee Mile	1.41
End Levee Mile	1.41
Location	Land Side
Category	Earthen Levee
Item	Vegetation

Looking southwest at elderberries on landside slope.

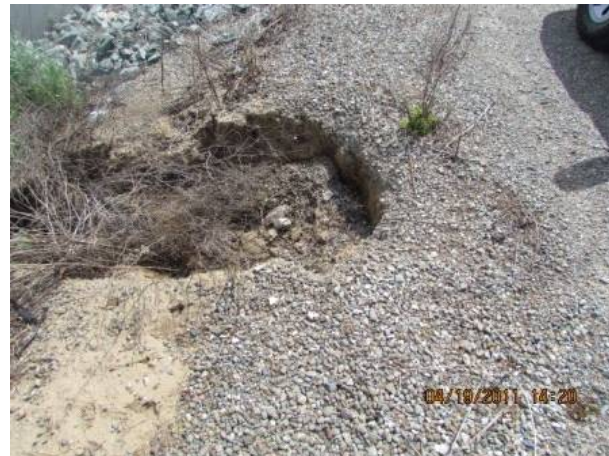
richard_f_20111014_827.jpg

Levee Mile Report Line	18
Start Levee Mile	1.89
End Levee Mile	1.89
Location	Water Side
Category	Earthen Levee
Item	Slope Stability

Looking southeast at depression greater than 6" and slope stability on waterside shoulder and slope.

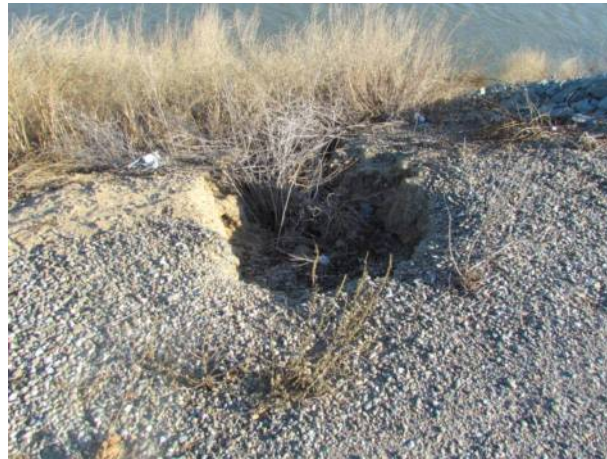
richard_f_20111205_481.jpg

Levee Mile Report Line	18
Start Levee Mile	1.89
End Levee Mile	1.89
Location	Water Side
Category	Earthen Levee
Item	Slope Stability

Looking east at caving on waterside shoulder. (Fall Inspection)

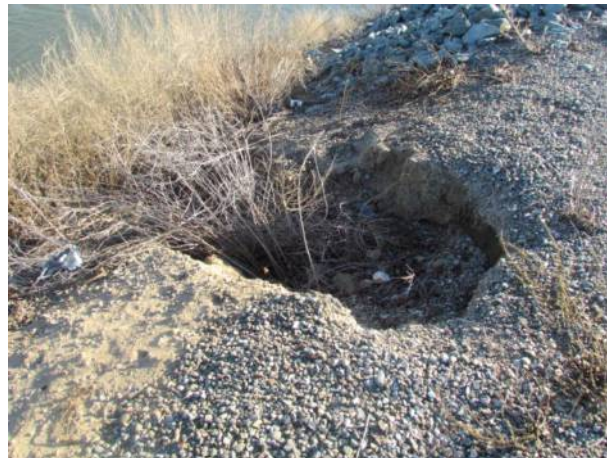
richard_f_20111205_482.jpg

Levee Mile Report Line	18
Start Levee Mile	1.89
End Levee Mile	1.89
Location	Water Side
Category	Earthen Levee
Item	Slope Stability

Looking southeast at caving on waterside shoulder. (Fall Inspection)

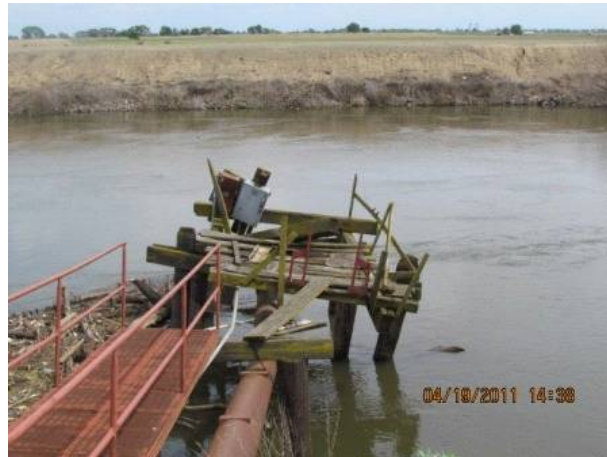
richard_f_20111014_829.jpg

Levee Mile Report Line	27
Start Levee Mile	2.64
End Levee Mile	2.64
Location	Water Side
Category	Channels
Item	Encroachments

Looking east at dilapidated pump platform.

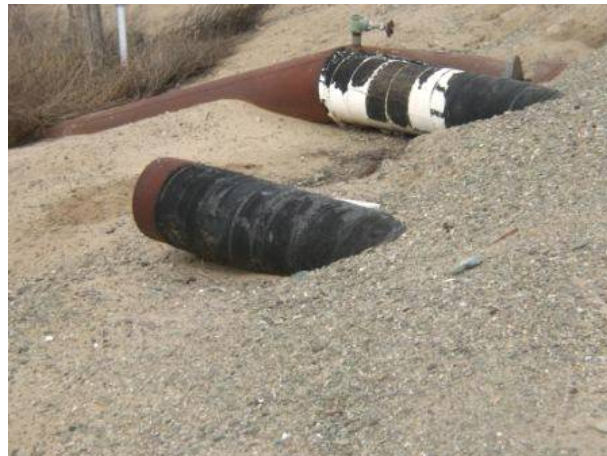
richard_f_20111014_826.jpg

Levee Mile Report Line	28
Start Levee Mile	2.65
End Levee Mile	2.65
Location	Crown
Category	Earthen Levee
Item	Encroachments

Abandoned pipe at LM 2.65, landside view.

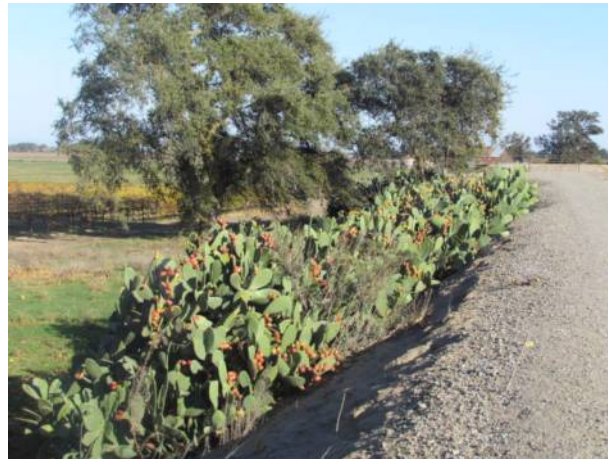
richard_f_20111205_480.jpg

Levee Mile Report Line	30
Start Levee Mile	3.53
End Levee Mile	3.56
Location	Land Side
Category	Earthen Levee
Item	Vegetation

Looking north at cactus on landside slope and toe.
